A MULTIDISCIPLINARY APPROACH TO UNDERSTANDING HISTORIC ARCHITECTURAL FAÇADES/

Abstract. The current article is part of a broader theoretical approach to studying the architectural façade, and it aims to reveal, in a technical manner, good practices for understanding the historical architectural façade.

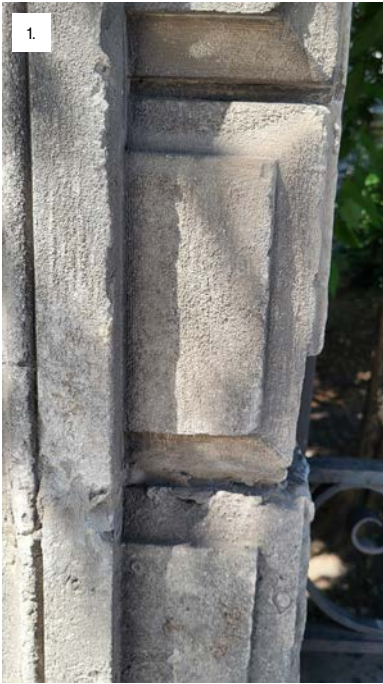
Starting the list is a valuable example, the plaster render of a pilaster at Monteoru House. The first image, FIGURE 1, is important because of the trowel technique used, a combed texture with vertical lines that conduct the raindrops in this direction. So the raindrops are quickly drained; there is no water stagnation, and this can improve and maintain a good quality visual appearance of the façade over time.

FIGURE 1 - Pilaster, covered in plaster, Monteoru House, situated on Calea Victoriei street, Bucharest, copyright author of the paper.

As previously stated, this combed technique can contribute to the overall durability of the façade by conducting the raindrops properly. Also, the grooves can mask minor imperfections or wear over time, maintaining an appealing surface for longer compared to smooth finishes that show cracks and stains more easily.

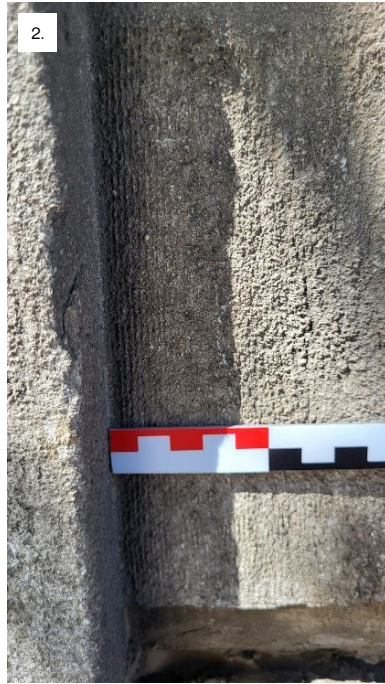
FIGURE 2 - Detail, plaster of pilaster at Monteoru House, situated on Calea Victoriei street, Bucharest, copyright author of the paper.

Regardless of the application complexity of this type of plaster, the aesthetic appeal of the combed plaster technique adds visual interest with its unique linear patterns and can suit various architectural styles. It was often used in the Art Nouveau period and in the early 1920s by architect Horia Creanga to embellish the main façade of his very first commission that marked his return from Paris, which was the residential building located on Bv. Schitu Măgureanu no.19, Bucharest.

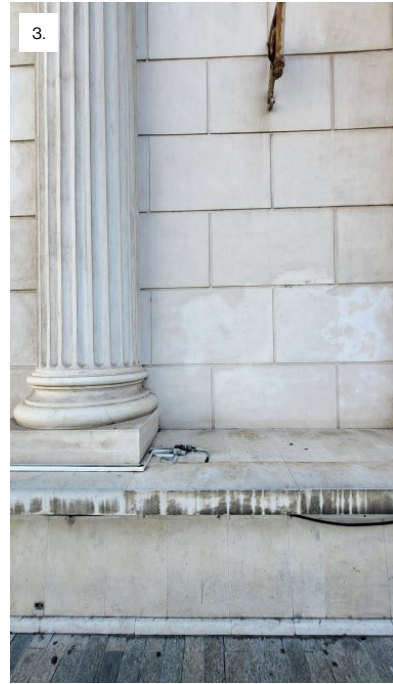
In comparison, the next example would showcase some improper or less desired results when applying a plaster render finish to the façade. The analysis will focus on the Romanian Athenaeum, a neoclassical cultural icon of the city, designed by architect Albert Galeron and finished in 1888. Although it had some interventions and restoration works during the last century, the last major one finished in 2004-2005. The visual analysis of the plaster highlights the following aspects: The finishing layer of paint gives a less mineral aspect to the plaster, it creates a fine, film-like look. Underneath the paint, the last stroke on the plaster had been done in a circular manner, which creates an uneven aspect of the bossage and even stains caused by the raindrops. This unguided water dripping on the façade may be a cause for the fine cracks observed on the surface of the plaster.

FIGURE 3 - Western, main façade of Romanian Athenaeum, Bucharest, plaster finished façade, copyright author of the paper.

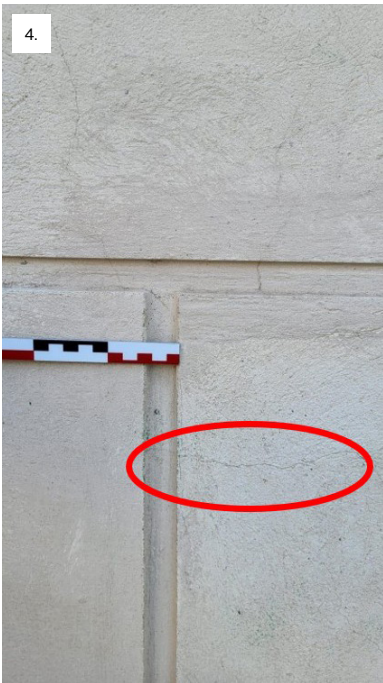
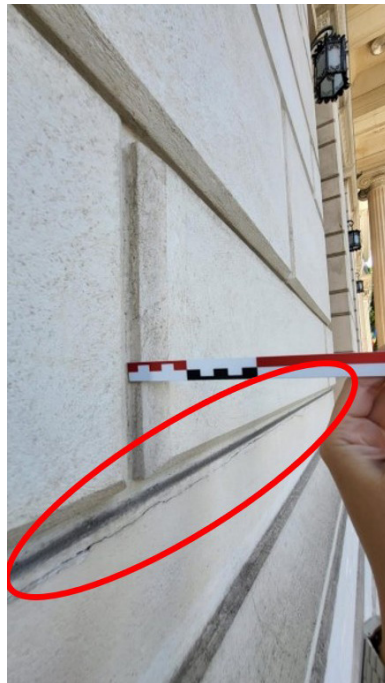
Focusing on the following photos, FIGURE 4, there is something to say about the degradation of the plaster just by visual observation: the lack of adequate slope at the joint of the bossage pieces can cause rainwater stagnation, which leads to stains and horizontal cracks. FIGURE 4a, 4b.

FIGURE 4 - (a), (b), Detail of the main façade, zoom on the plaster to showcase the cracks, copyright author of the paper.

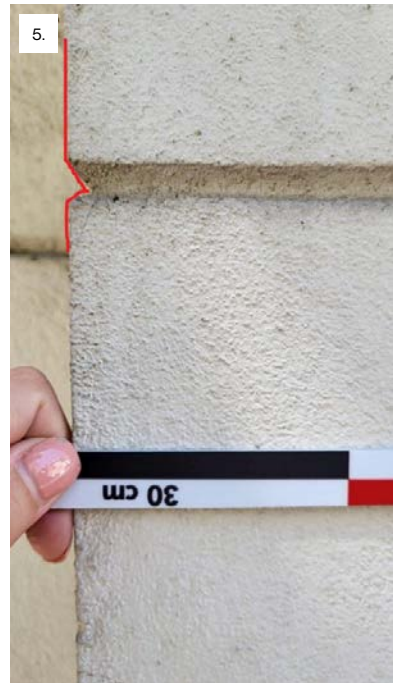
The following example, FIGURE 5, will showcase a type of joint that has an adequate slope and there are no visible cracks caused by water stagnation.

FIGURE 5 - Detail of the eastern façade, of Theodor Aman Museum, Bucharest, copyright author of the paper.
